Reliability Analysis of SnPb and SnAgCu Solder Joints in FC-BGA Packages with Thermal Enabling Preload

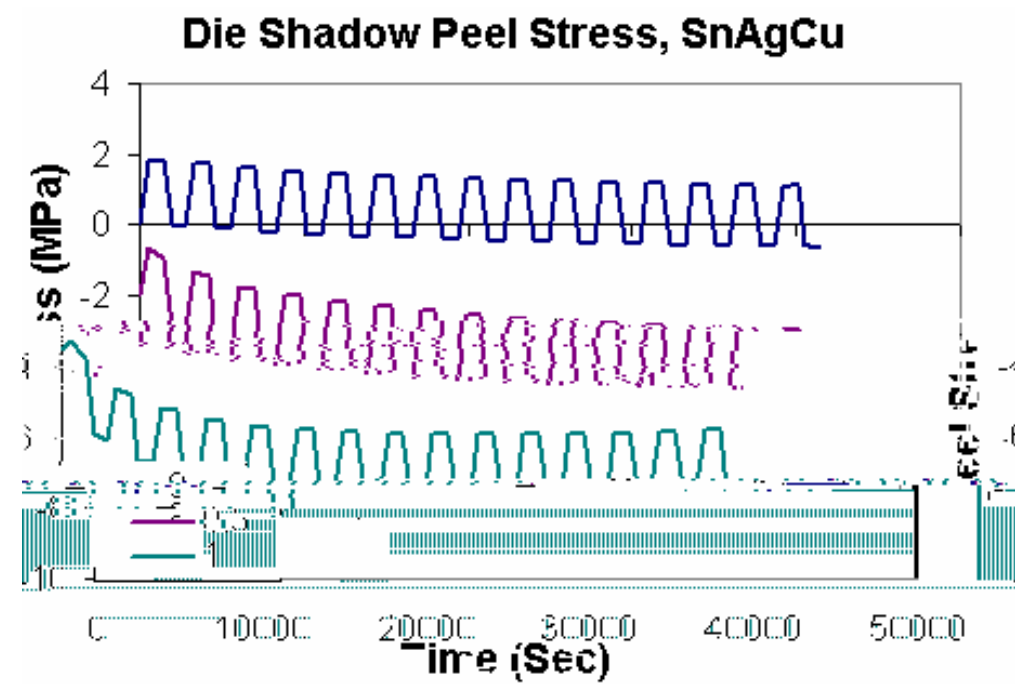
(a) Corner of die shadow

Figure 17: Peel stress history of SnAgCu solder
